XYPEX CRYSTALLINE TECHNOLOGY

Sustainable Concrete Construction

Xypex Crystalline Technology Contributes To Sustainable Construction

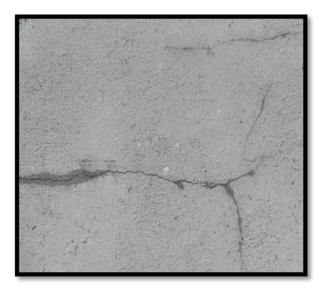
Cracks = Direct route for water ingress

- Ingress of water into concrete brings chlorides or sulfates.
- Ingress of water into concrete is the most common cause of concrete deterioration.
- Xypex crystalline can self-heal cracks up to 0.5mm.

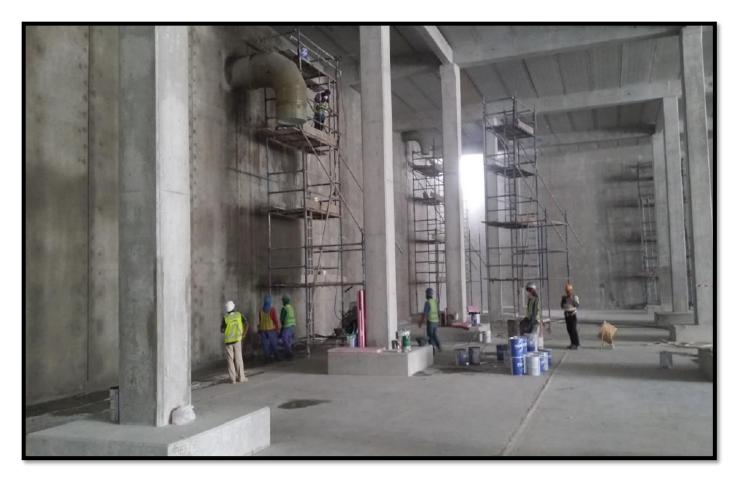
Xypex Crack Healing

- Ras Abbu Fontas Water Reservoir, Qatar
- Two potable water tanks
- 30,000 m² footprints
- 56,000 m² treated with 2 coats Xypex Concentrate
- 24,000 tie-holes treated with Patch'n Plug/Dry-Pac

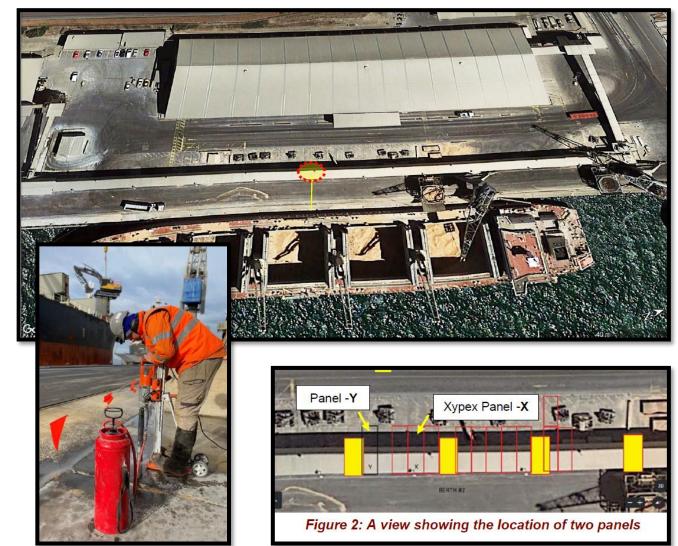
Lascelles Wharf in Port of Geelong, Australia

- 400 kg (881lbs) GP Cement, 40 Mpa (5800 psi), 0.45 W/C
- Minimum 51mm concrete cover
- Condition Assessment Conducted in
 - 2021 (26 years)

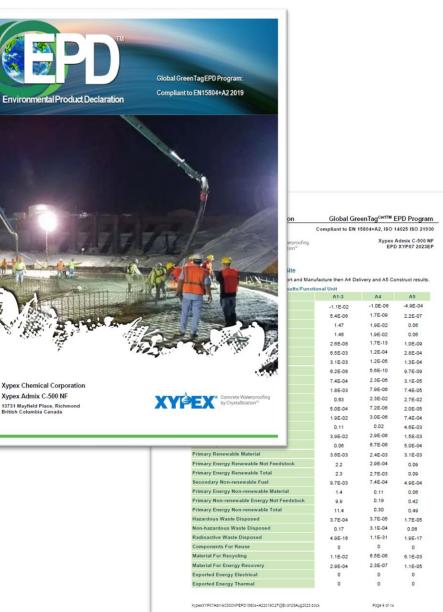
Third-Party Verified EPD

- 1.5 pts per product (LEED)
- Xypex C-500 NF Admix- A1-A5 (Manufacturing and Construction)

GWP $_{t}$ = 3.0 kg/m³ x 1.539 kg CO_{2eq}

- = 4.62 kg CO_{2eq}
- ~ 7 kg of Ordinary Portland Cement
